**TEARDOWN REPORT  
OF TWO MODEL TPE331-10T-515K TURBOPROP ENGINES  
SERIAL NUMBER P-79297C AND P-79001C**

**October 8, 2014**

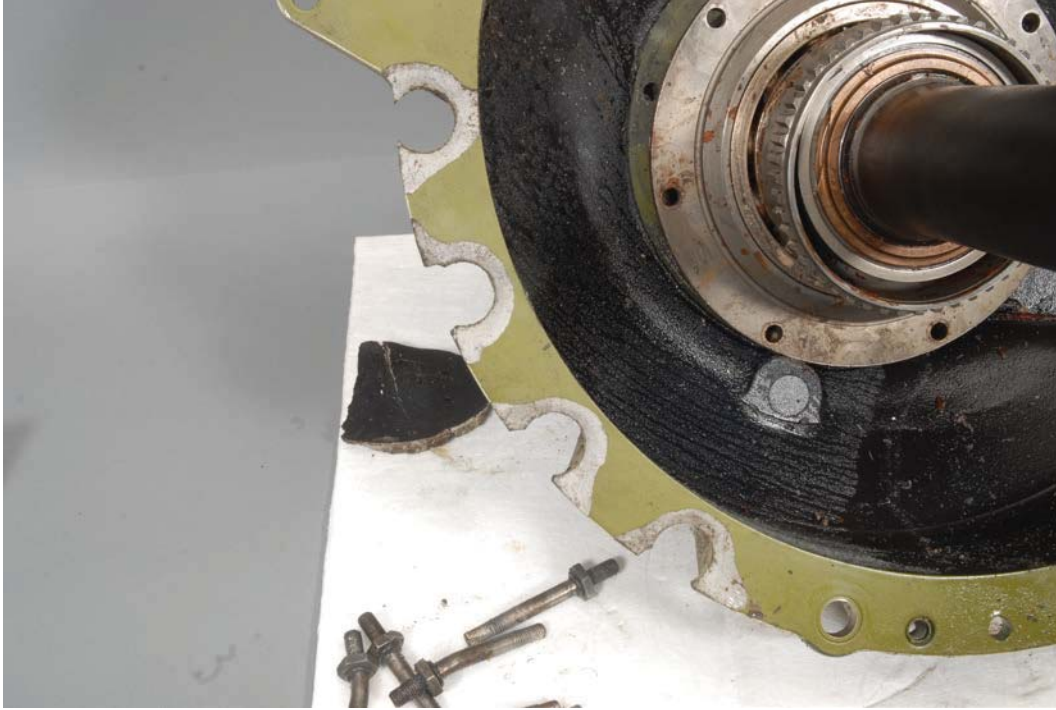
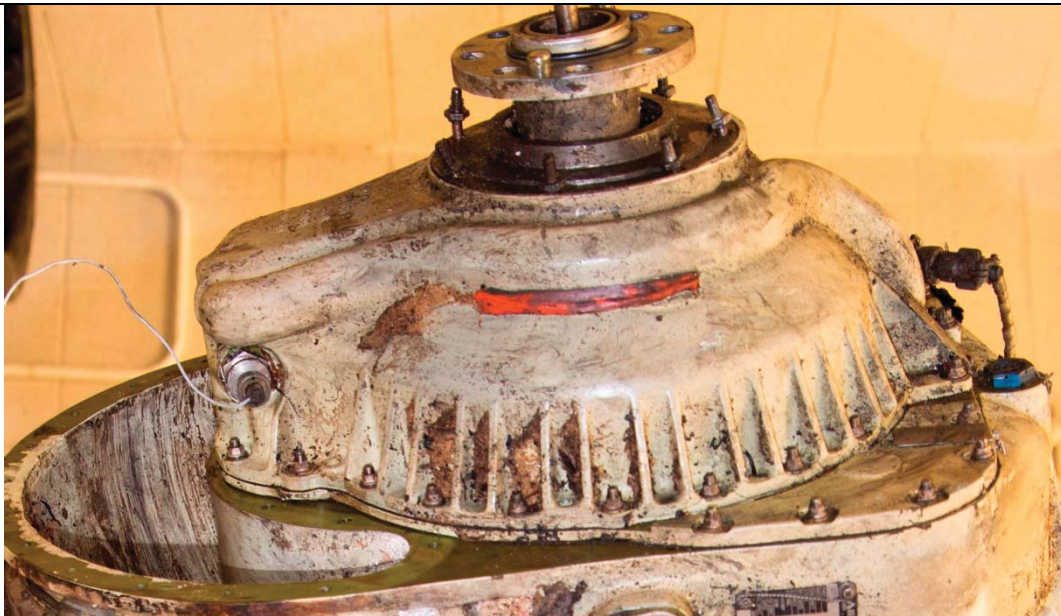
- (a) Nose Cone Housing:
  - The nose cone assembly was cracked in multiple locations. (Figure 18 and Figure 19)
  - There was black debris, consistent with fire soot, and earthen debris adhering to the external surfaces of the nose cone assembly. (Figure 20)
  - There was light grey debris, and earthen debris adhering to the internal surfaces of the nose cone assembly. (Figure 21)

**Figure 18.** P-79297C, Nose Cone Assembly, Cracks/Fractures

**Figure 19.** P-79297C, Nose Cone Assembly, Cracks/Fractures

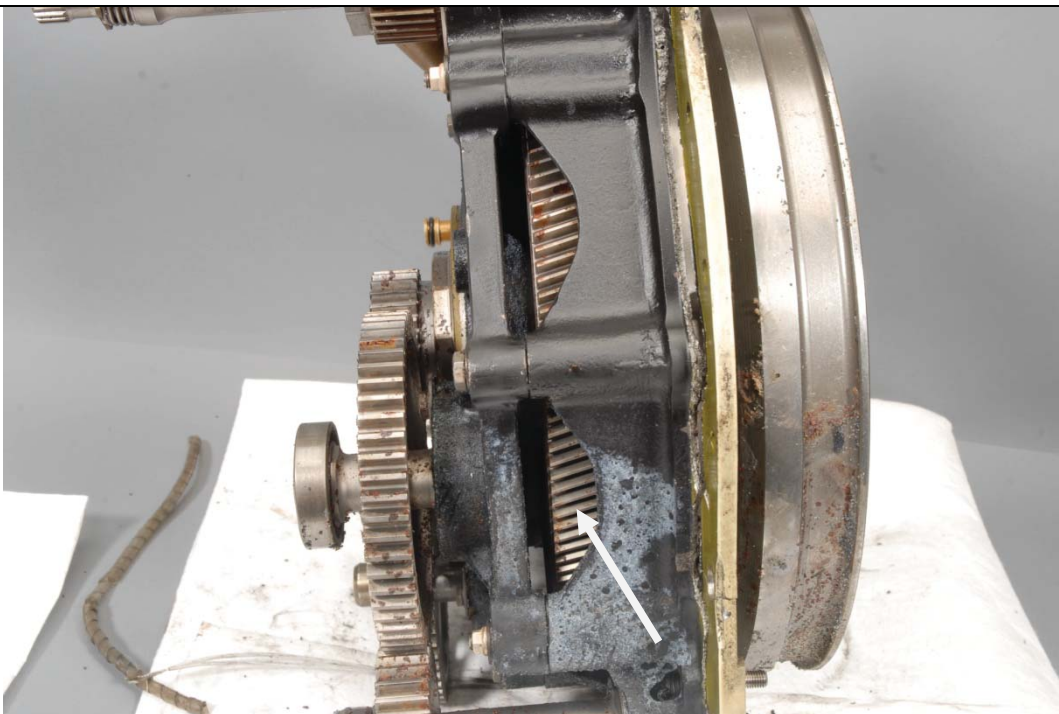
- All gears and bearings of the diaphragm housing were intact. All gears were free to rotate.
  - The diaphragm housing mount flange was fractured from the housing from the 2 to 9 o'clock position. (Figure 37)

**Figure 37. P-79297C, Diaphragm Housing Fracture**

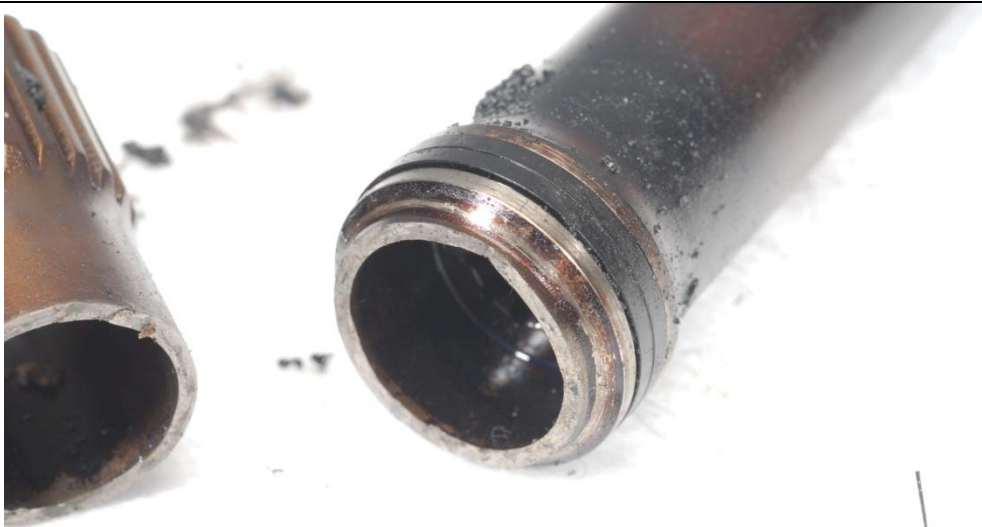
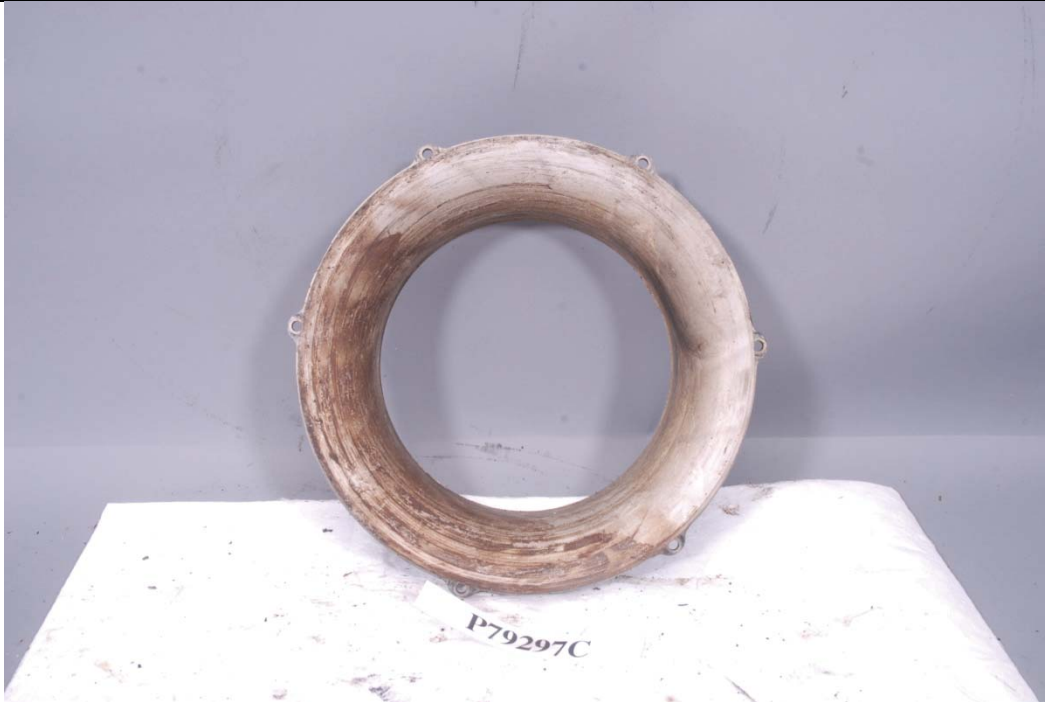
- (b) Torsion Shaft: (Figure 91 and Figure 92)
- The torsion shaft was separated just forward of the aft splines. The torsion shaft was not submitted for material analysis. However, the characteristics of the fracture surfaces were typical of a torsional overload separation.

**Figure 92. P-79297C, Torsion Shaft Shear Fracture**

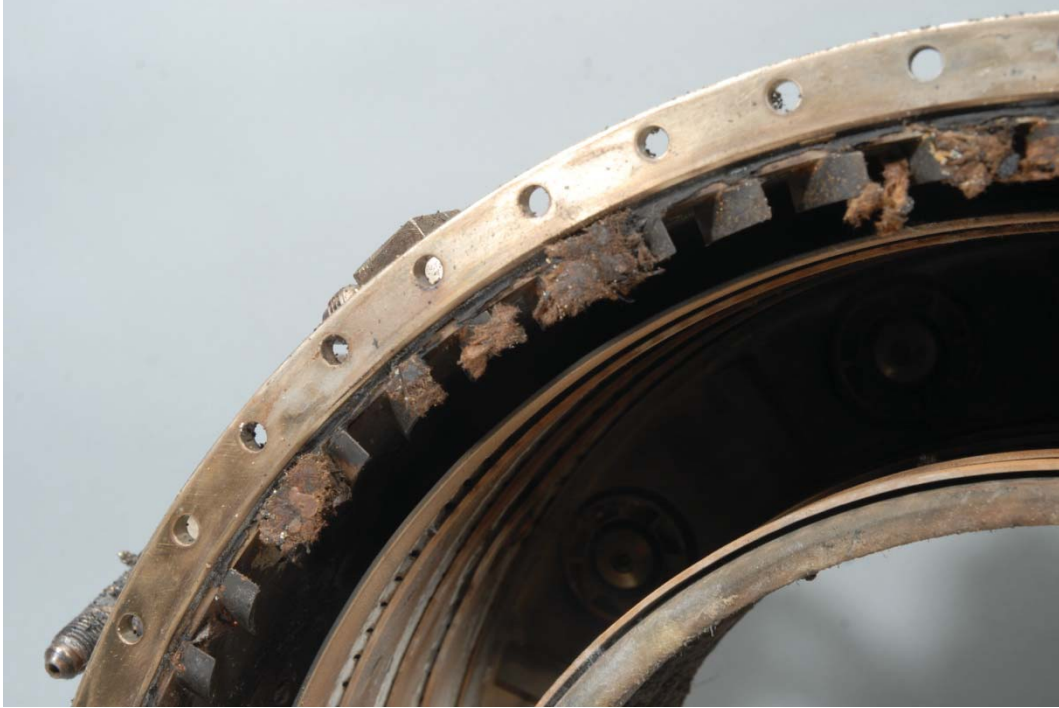
**Figure 122. P-79297C, Combustor Plenum Case, Impact Damage**

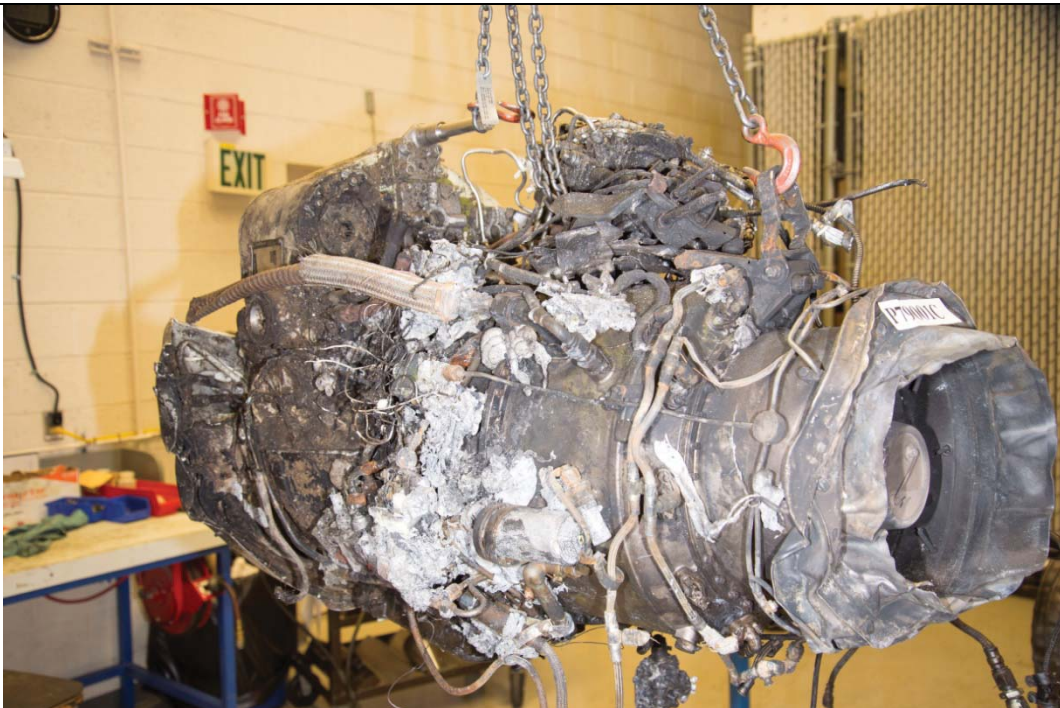
- Various engine interface control cables.
- d) The engine was generally intact however the Intermediate case was fractured at the mounting flange to the compressor case. (Figure 211, Figure 212 and Figure 213) Upon disassembly, it was noted that entire gearbox had heavy corrosion in the internal case surfaces and ferrous based components. Unless otherwise noted, all internal gear box components exhibited heavy corrosion.

**Figure 213. P-79001C, Intermediate Case Fracture**

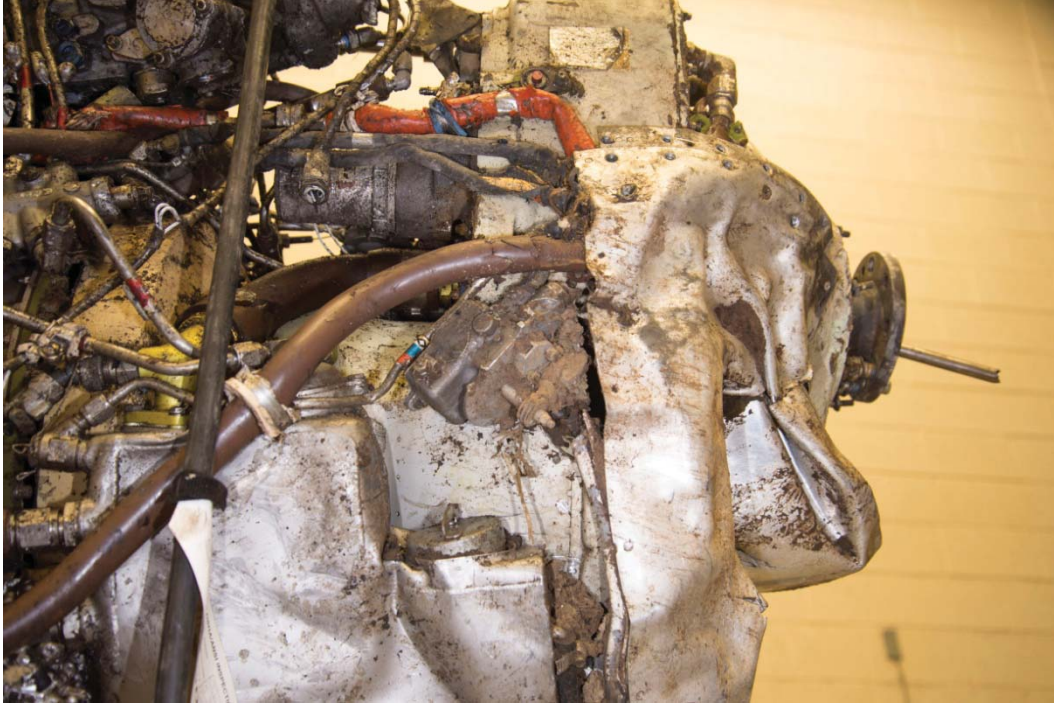
- e) The engine displayed evidence of fire damage. (Figure 214)
- f) The engine displayed evidence of impact damage. (Figure 215)
- g) The engine propeller shaft would not rotate.

**Figure 214. P-79001C, Fire Damage**

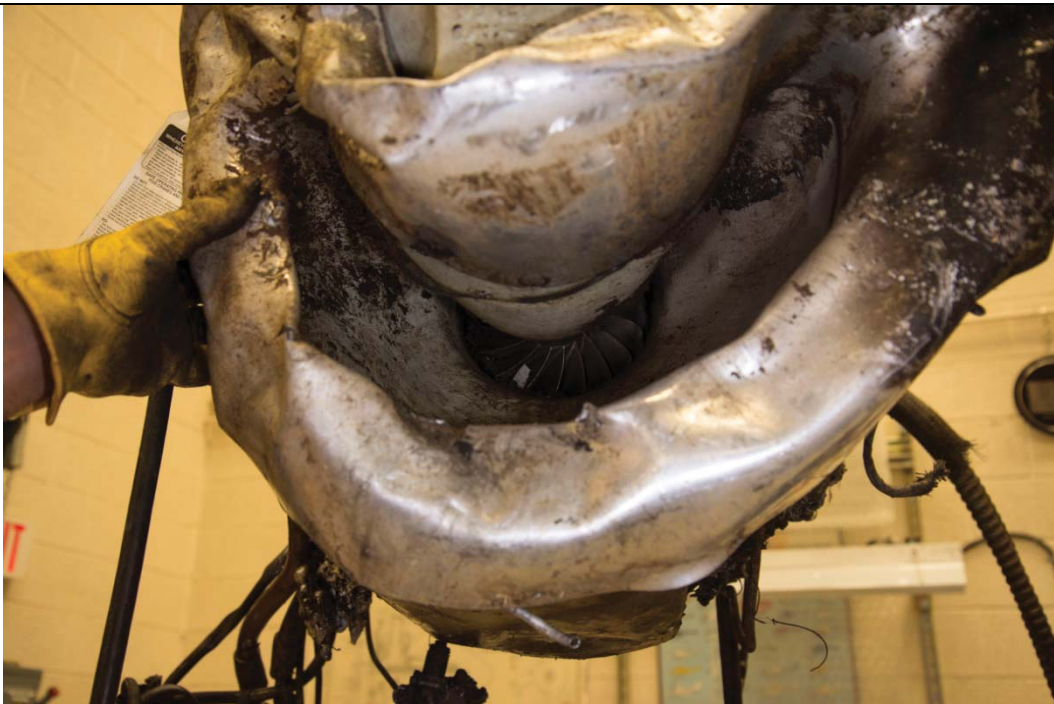
**Figure 215. P-79001C, Impact Damage**

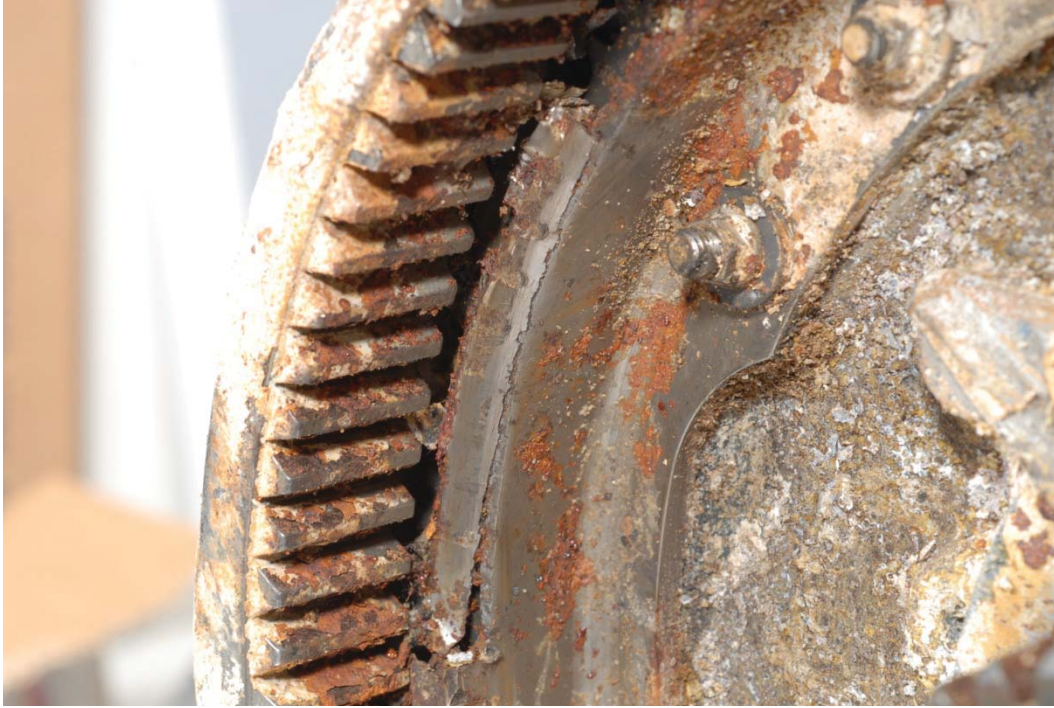
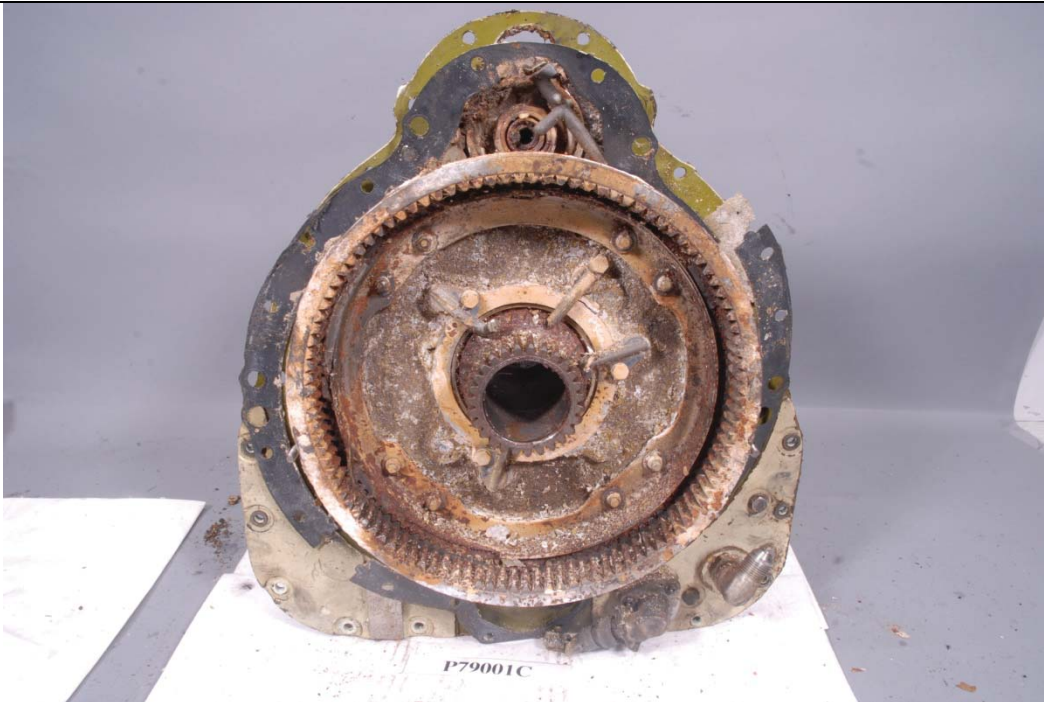
- (c) Ring Gear Support:
  - The ring gear support (bumper plate) displayed rotational scoring to the forward face and was fractured in two places, (Figure 236 and Figure 237) with corresponding score marks on the aft face of all of the planet gears.

**Figure 236.** P-79001C, Ring Gear Support, Fracture

**Figure 237.** P-79001C, Ring Gear Support, Fracture

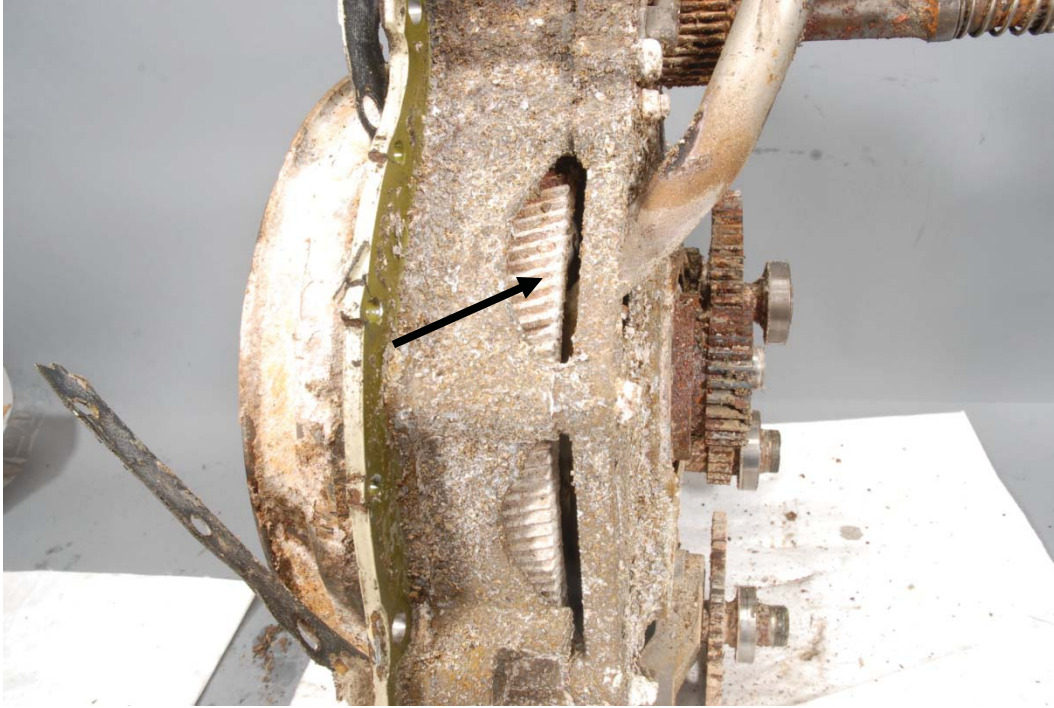
**Figure 240.** P-79001C, Diaphragm Housing, Bolt Hole Fractures

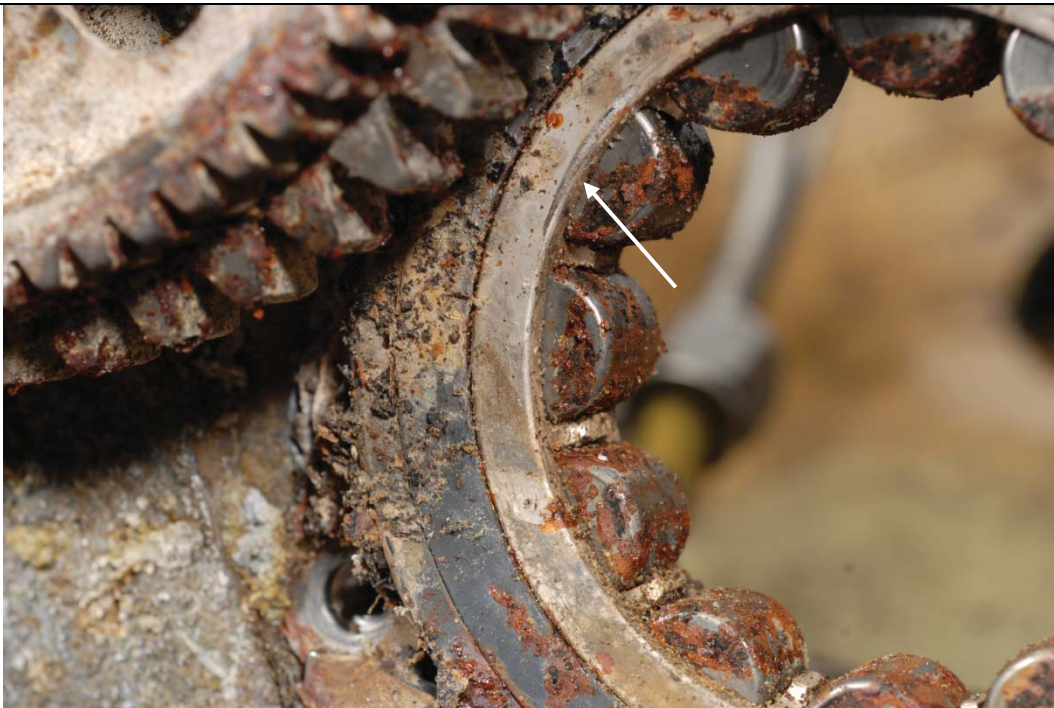
**Figure 261.** P-79001C, Propeller Shaft Aft Roller Bearing, Outer Race Fracture

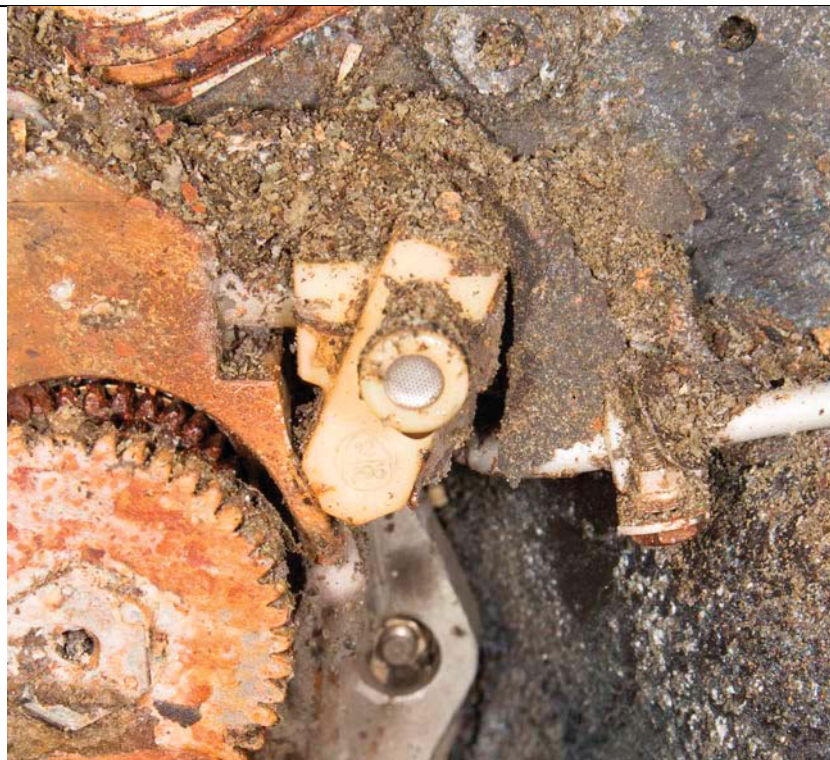
**Figure 275.** P-79001C, Feather Valve Oil Transfer Tube Mount Boss, Impact Damage

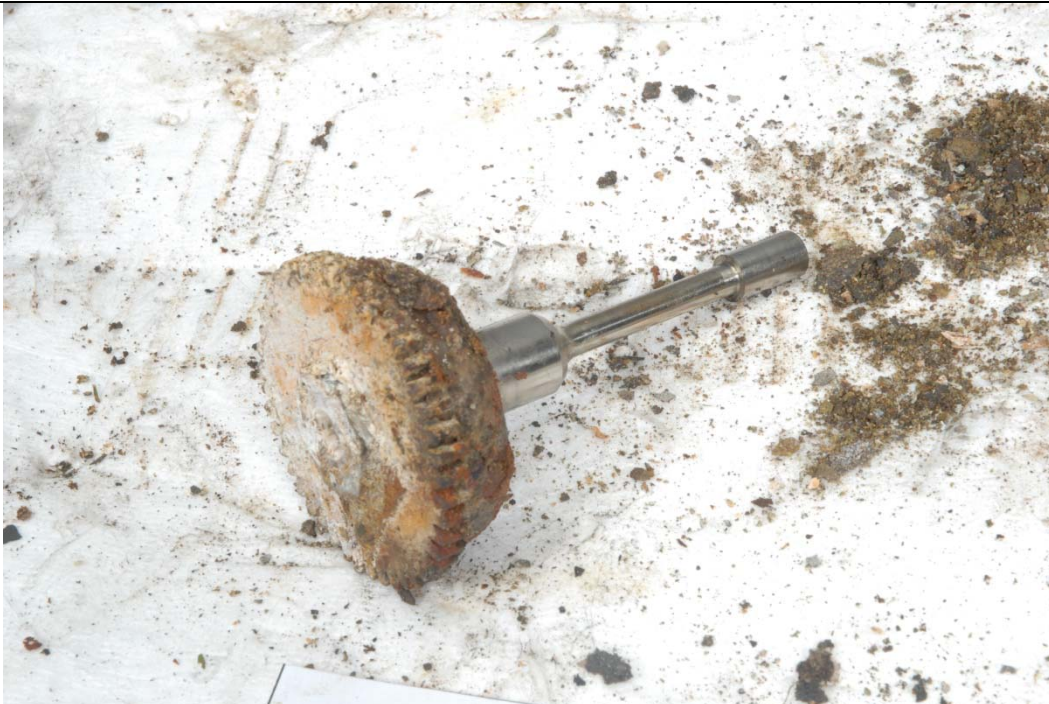
**Figure 281.** P-79001C, Torque Sensor, Impact Damage

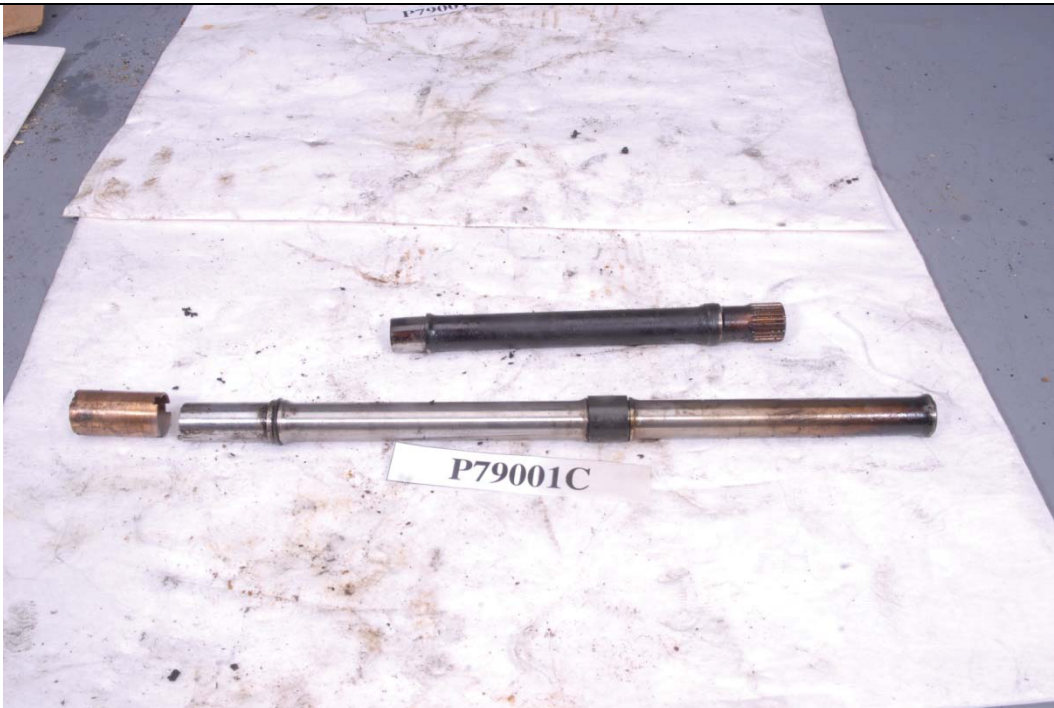
**Figure 289.** P-79001C, Shouldered (Main) Shaft, Spline Damage

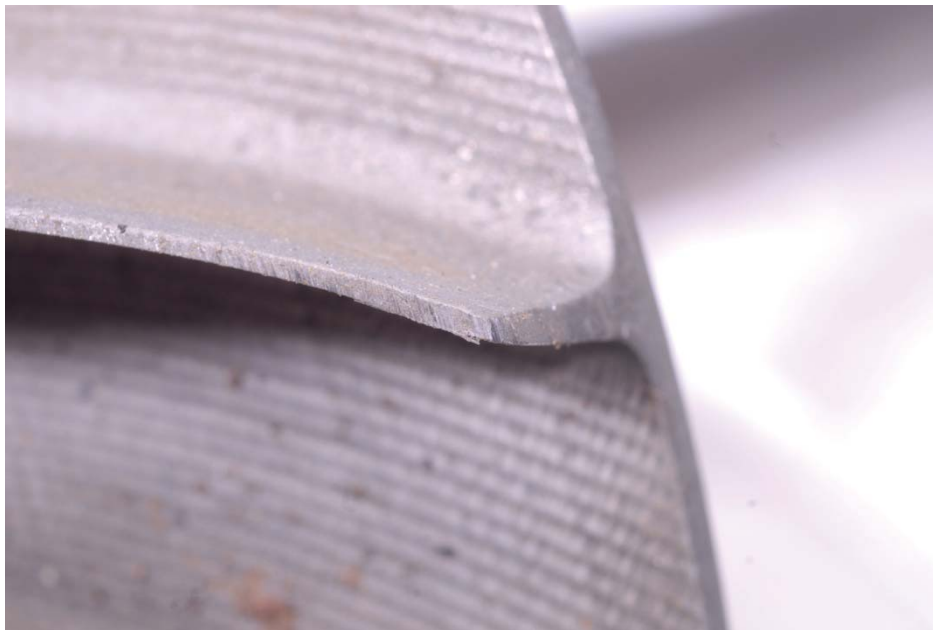
**Figure 297.** P-79001C, First-Stage Compressor Impeller, Leading Edge Blade Damage

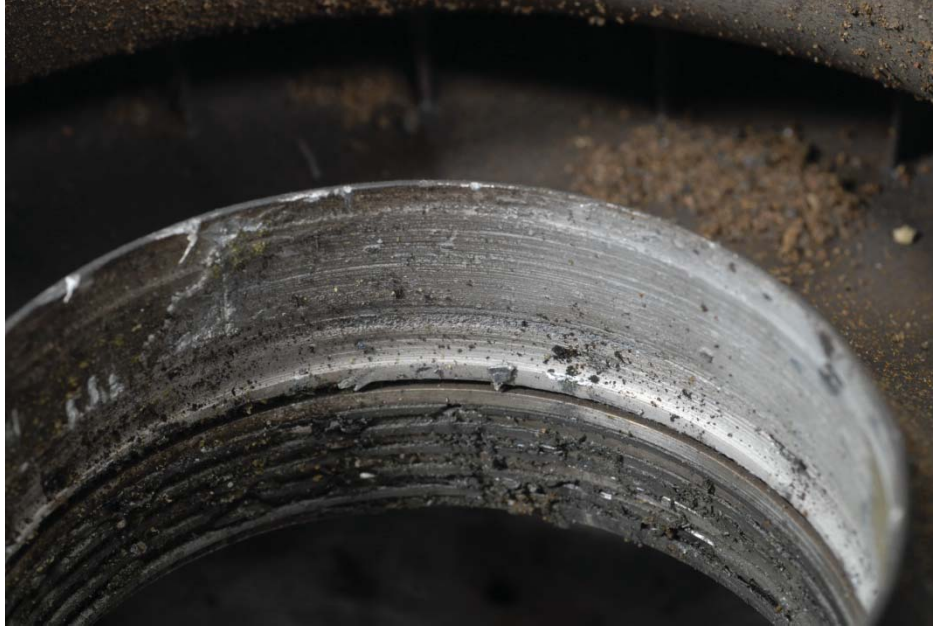
**Figure 304.** P-79001C, First-Stage Compressor Diffuser, Vane Leading Edge Damage

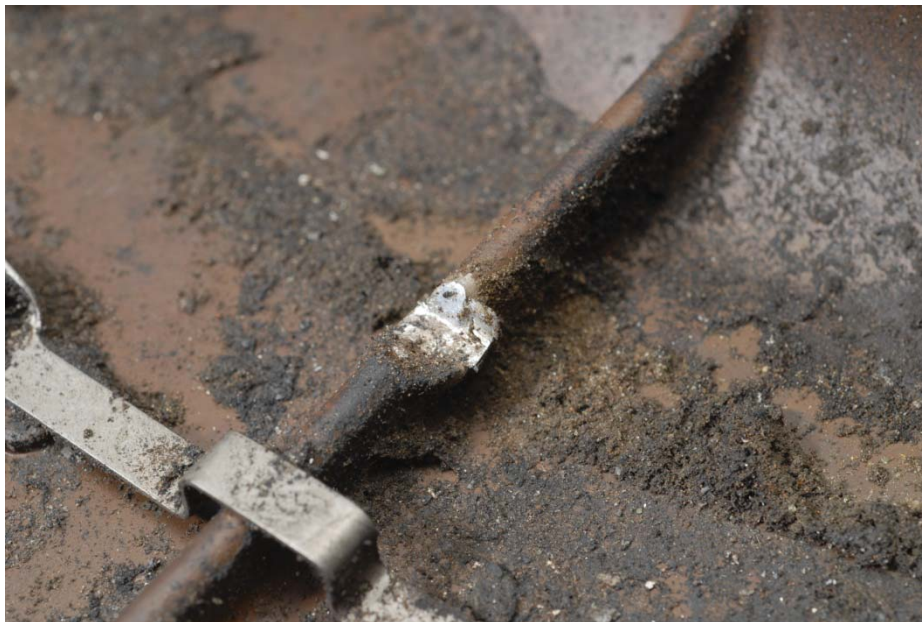
**Figure 305.** P-79001C, First-Stage Compressor Diffuser, Rotational Scoring

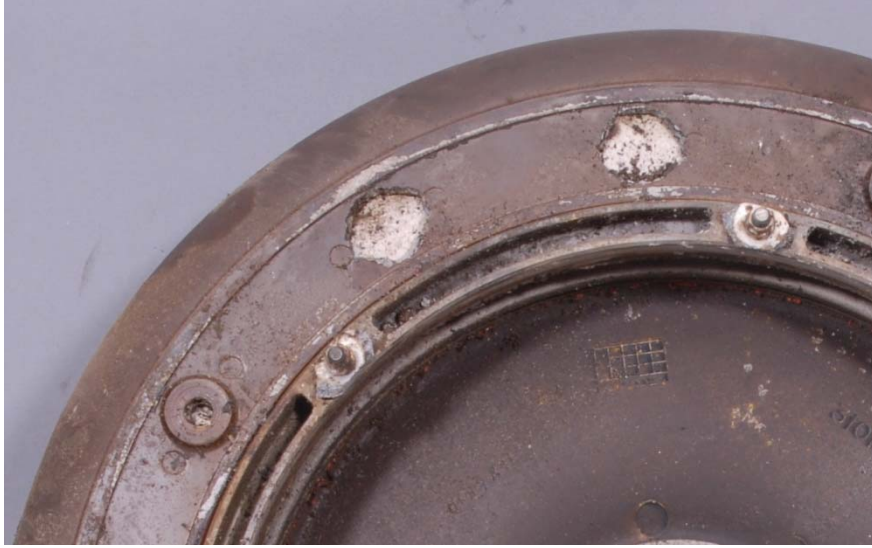
**Figure 306.** P-79001C, First-Stage Compressor Diffuser, Impact Damage

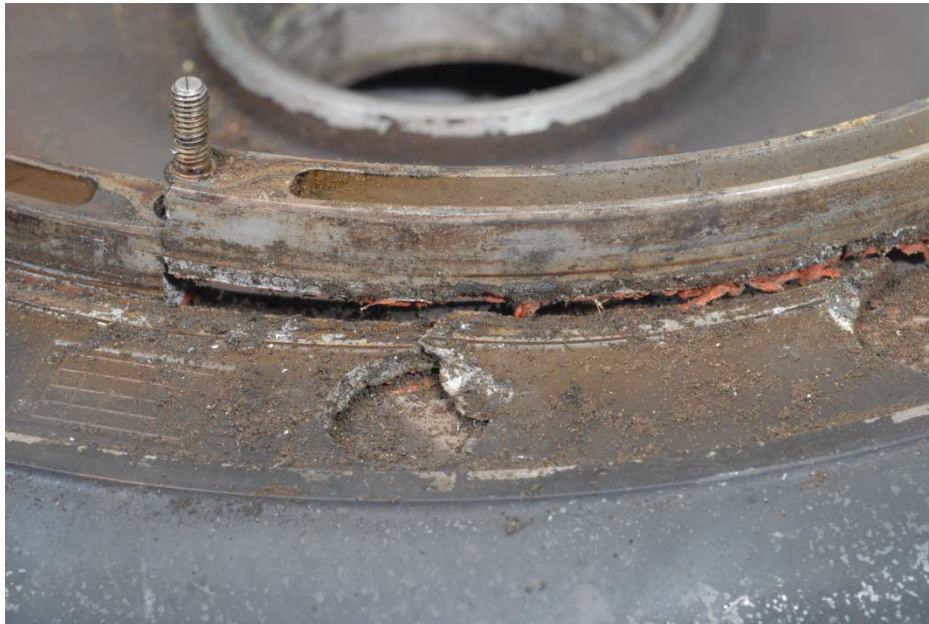
**Figure 307.** P-79001C, First-Stage Compressor Diffuser, Stud Fractures

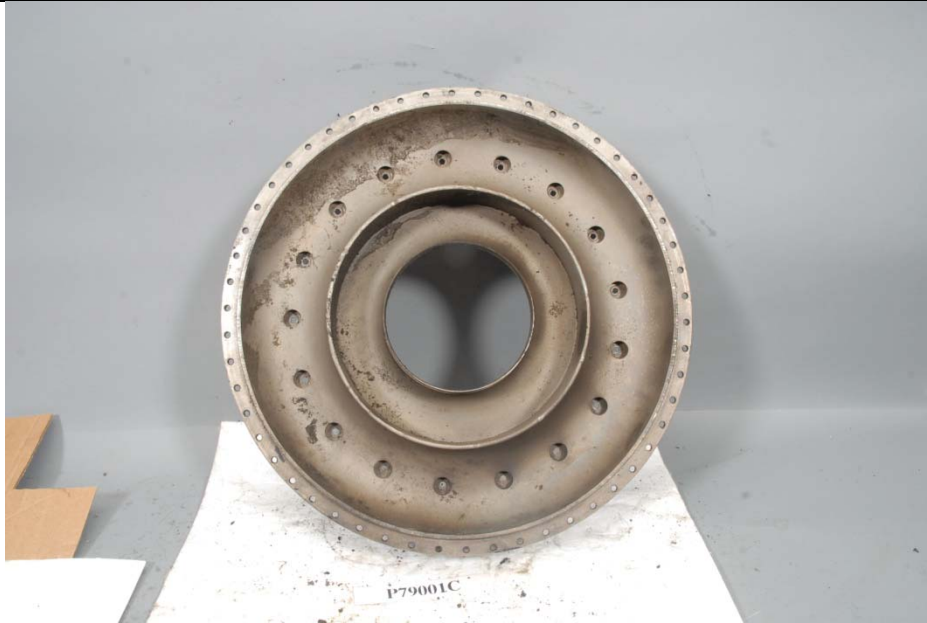
**Figure 308.** P-79001C, First-Stage Compressor Diffuser, Mount Flange Fracture

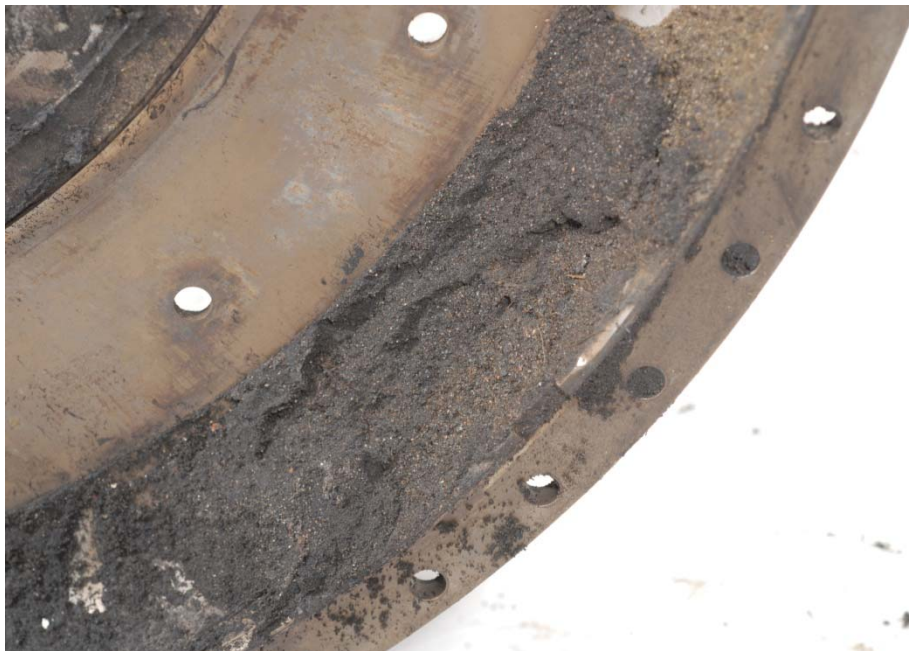
**Figure 311.** P-79001C, Second-Stage Compressor Housing, Axial Compression Damage

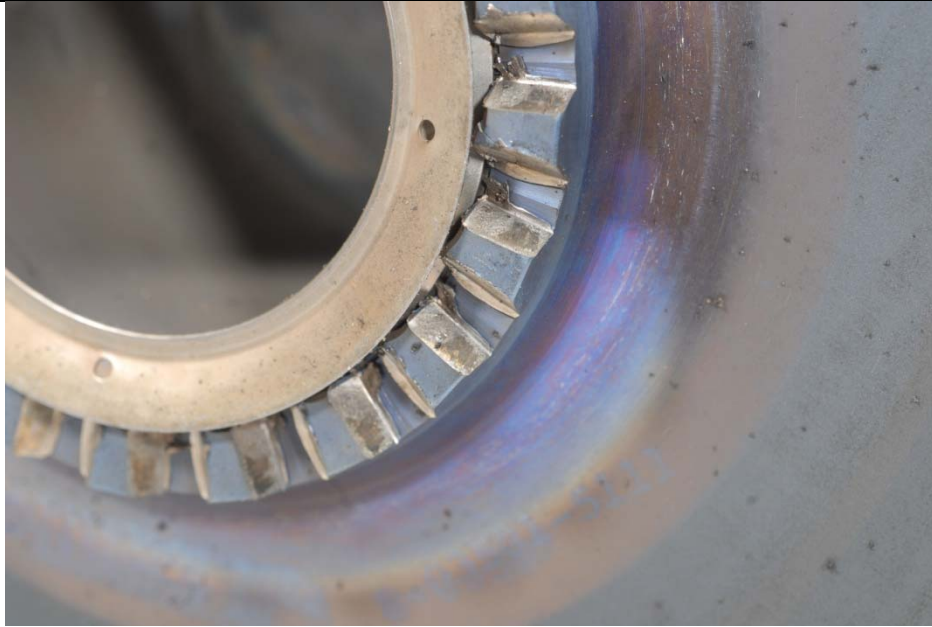
**Figure 318.** P-79001C, Second-Stage Compressor Impeller, Forward Hub and Curvic Damage

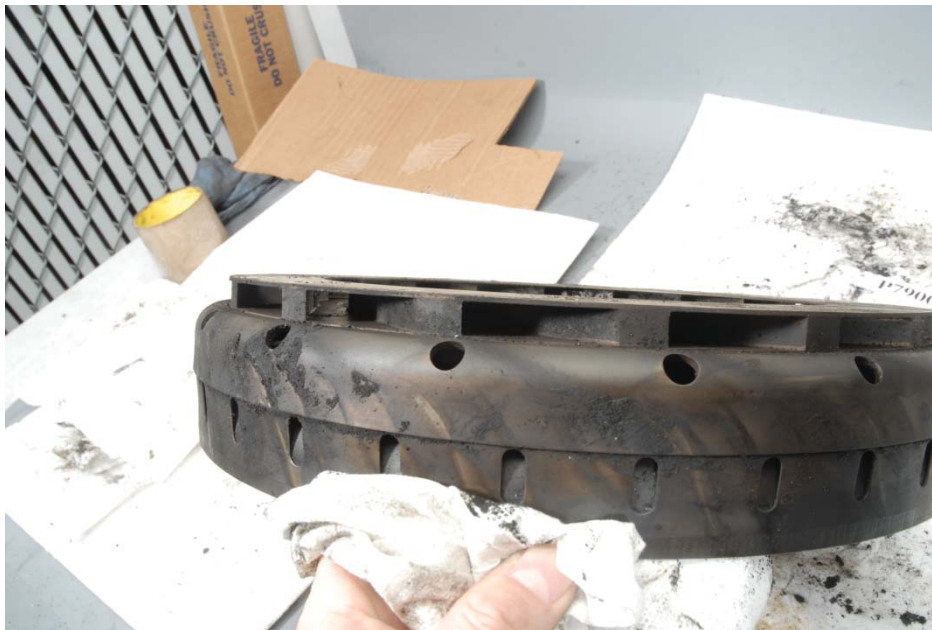
**Figure 319.** P-79001C, Second-Stage Compressor Impeller, Aft Curvic Damage

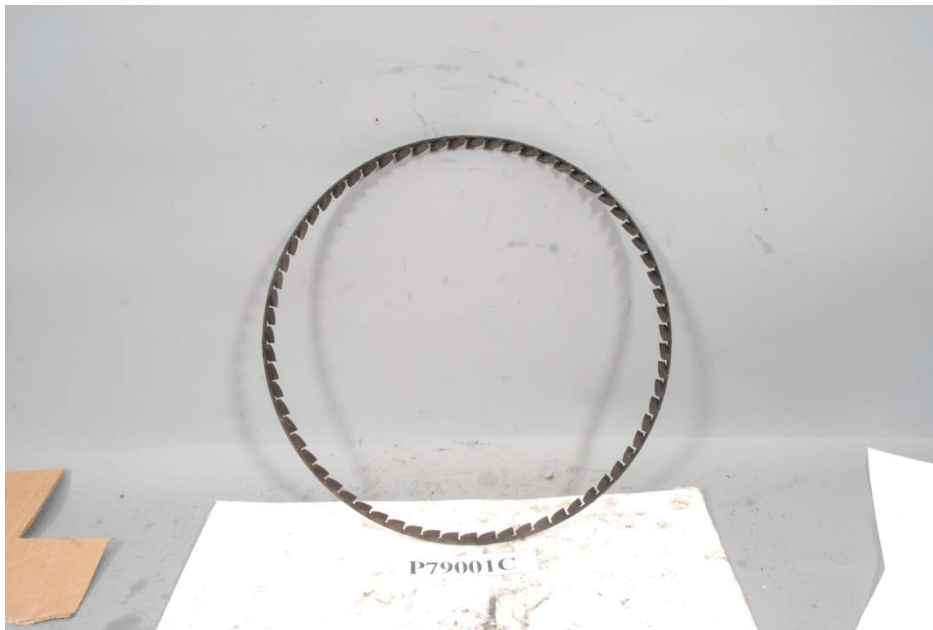
**Figure 325.** P-79001C, Combustor Plenum Case, Impact Damage

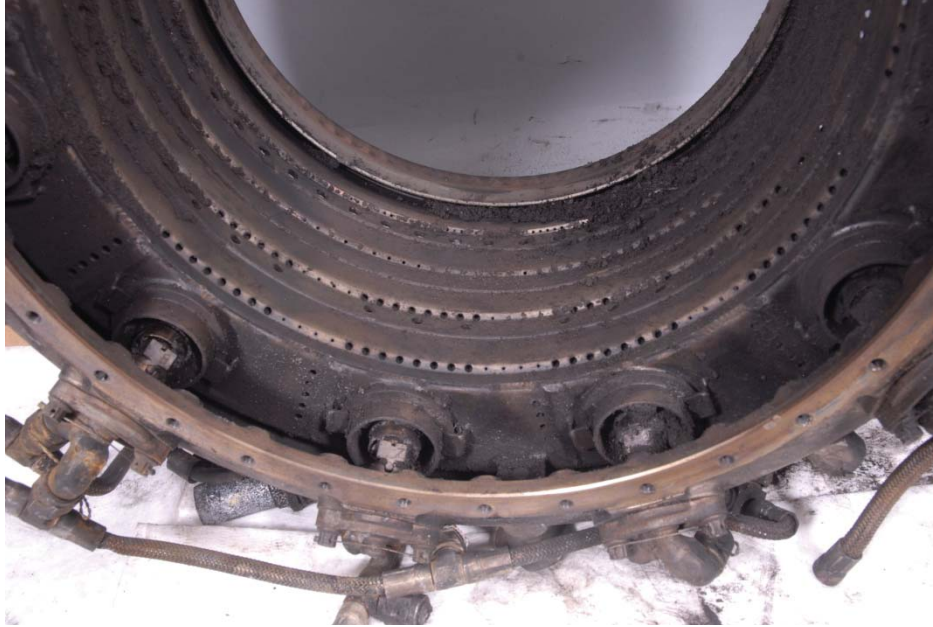
**Figure 328.** P-79001C, Combustor Chamber, Impact Damage

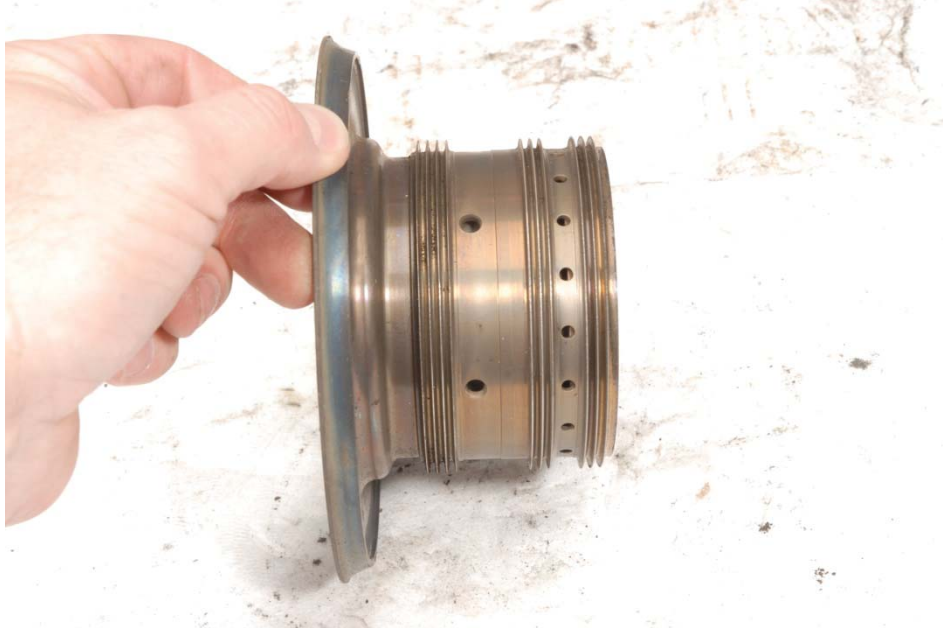
**Figure 332.** P-79001C, Outer Transition Liner, Impact Damage

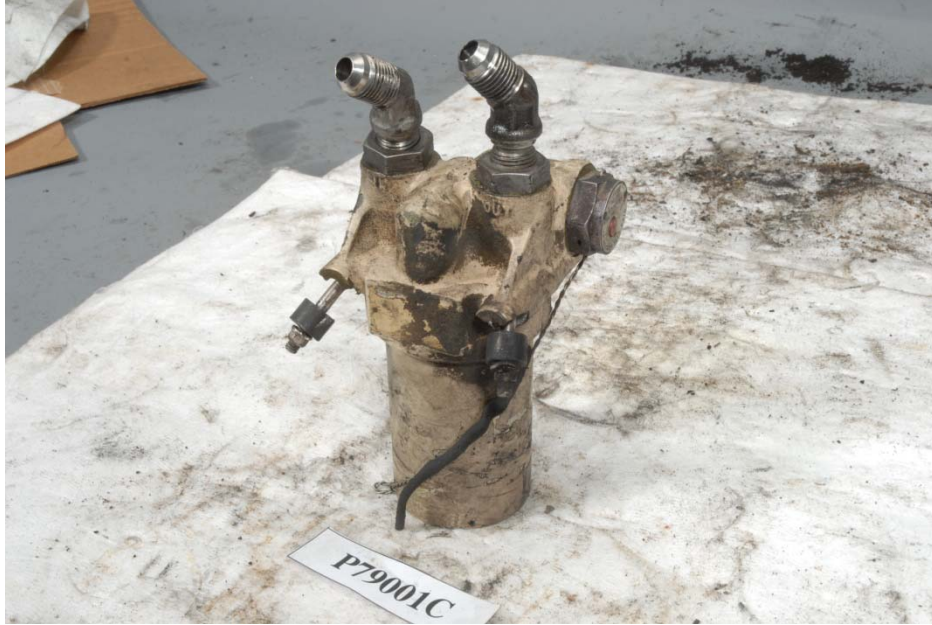
**Figure 392. P-79001C, Fuel Control, Impact Damage**

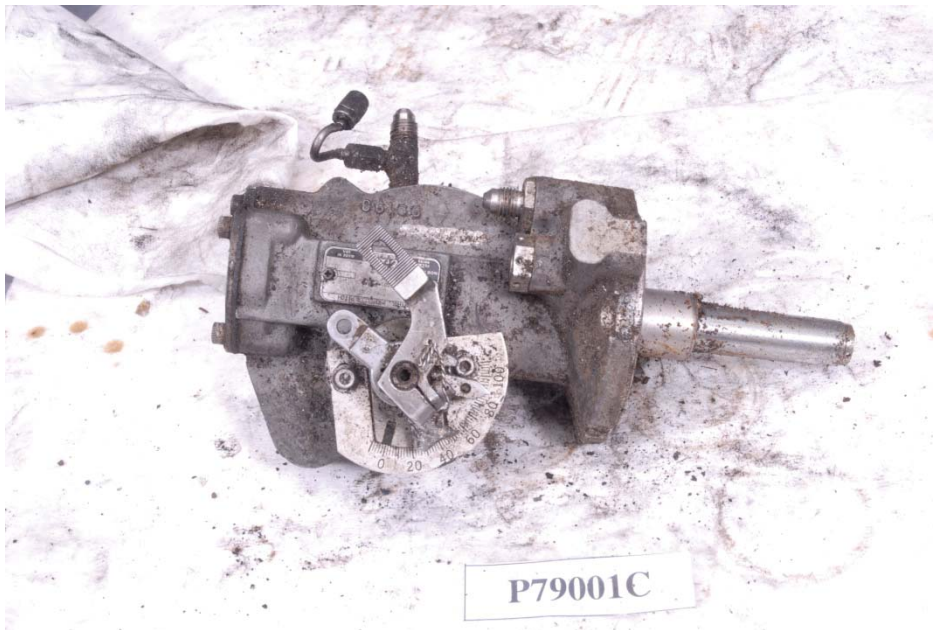
**Figure 401.** P-79001C, Propeller Governor, Fire Damage
